Solex PV electric tiles

The test was carried out in accordance with;
DD CEN/TS 1187:2012 – Test 4
Test Methods for External Fire Exposure to Roofs

DD CEN/TS 1187:2012 Test Methods for External Fire Exposure to Roofs – Test 4: Method with Two Stages Incorporating Burning Brands, Wind and Supplementary Radiant Heat

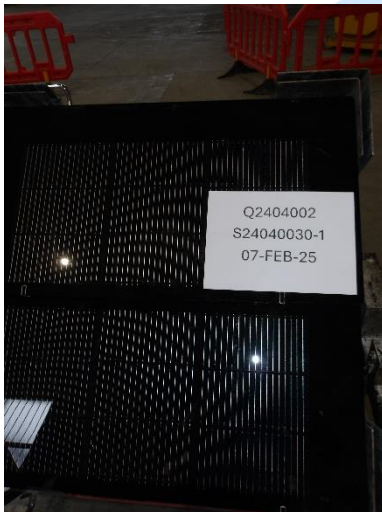
Stage 1 – S24040030-1

Pre-Test Specimen Picture

Sample Number:	S24040030-1
Lab Temperature [°C]:	16.5°C
Duration of Flaming [min:sec]:	00:13
Extent of Flame Spread [mm]:	0mm
Penetration Occurred:	No
Time [min:sec]	Observations
00:00	Start of test -burning brand applied
00:60	Buring brand removed – Flaming on surface of specimen
01:13	Flaming ceases – end of test

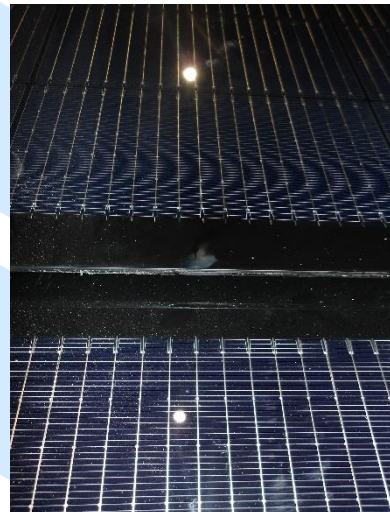
Post Test Picture

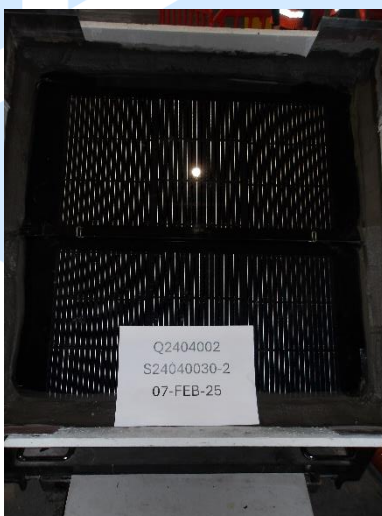
Stage 2 – S24040030-2

Pre-Test Specimen Picture

Specimen Number	Time [min:sec]	Observations
S24040030-2	00:00	Start of test
	05:00	Application of burning brand
	06:00	Removal of burning brand
	06:41	Bowing of specimen structure
	15:22	Surface scorch on PV tile
	28:42	Cracking of PV tile
	60:00	End of test

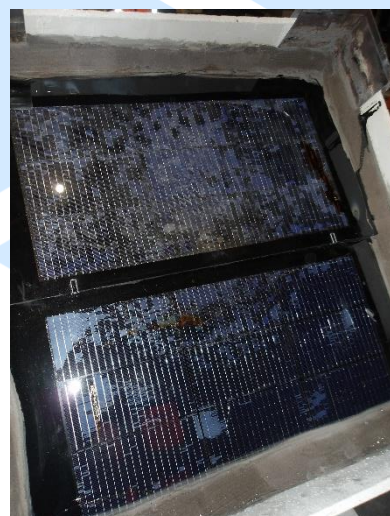
Post Test Picture

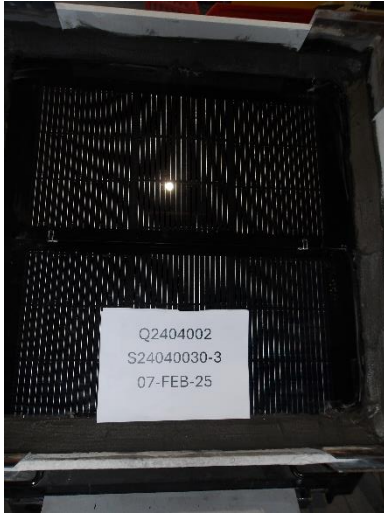
Stage 2 – S24040030-3

Pre-Test Specimen Picture

Specimen Number	Time [min:sec]	Observations
S24040030-3	00:00	Start of test
	05:00	Application of burning brand
	06:00	Removal of burning brand
	15:07	Surface scorch on PV tile
	60:00	End of test

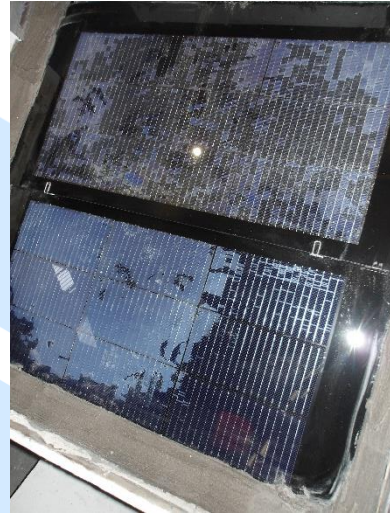
Post Test Picture

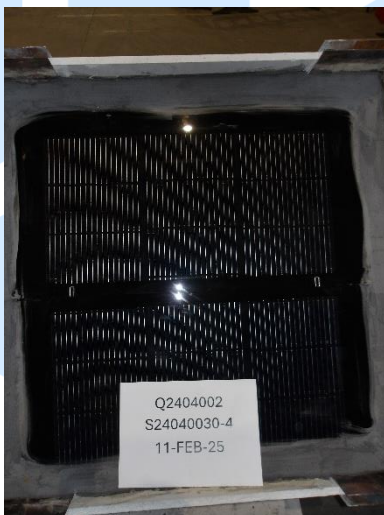
Stage 2 – S24040030-4

Pre-Test Specimen Picture

Specimen Number	Time [min:sec]	Observations
S24040030-4	00:00	Start of test
	05:00	Application of burning brand
	06:00	Removal of burning brand
	60:00	End of test

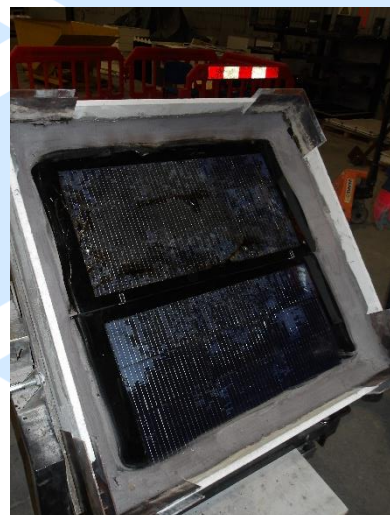
Post Test Picture
